## Situation 5 Left Motor Fault: THREE flashes of status LED

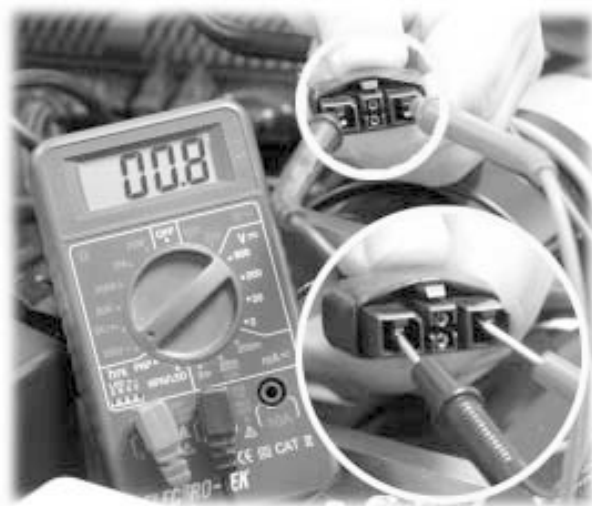
Figure 2.70. M1 Harness

The power chair interprets different faults by monitoring voltages and resistance values within the system. This error indicates that the power chair detects an “open” in the left motor or the left motor wiring. In order to determine exactly where the fault lies, unplug the 4-pin M1 harness of the power module. See Appendix H. Plug the harness back in and ensure that it has a good connection. Cycle the power on and off and see if the fault is still occurring. If it is, unplug this harness and turn the meter to a resistance scale. Take a reading across motor positive and motor negative on the M1 harness (two larger pins) after removing it from the power module. See figure 2.70.

If the system is working properly, you should get a reading approximately .5 to 1.5 ohms.

**If the reading appears within tolerance, replace the power module. If not, check the 4-pin connector to the motor to see if there is a bad connection.**

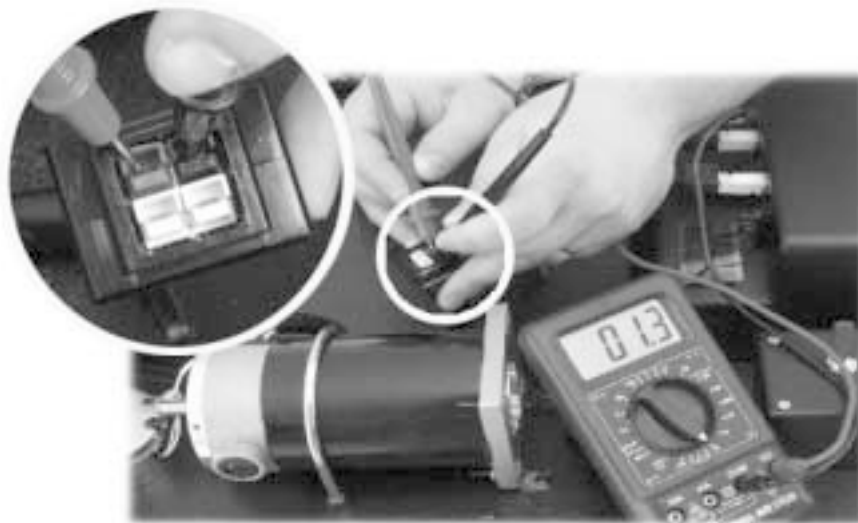
Figure 2.71. Motor Coil

Take a resistance reading from the heavy gauge red and black wires that run to the motor coil. See figure 2.71.

**Some chairs have red and black connectors attached to these wires.**

The reading across the motor coil should read approximately .5 to 1.5 ohms.

**If the reading appears outside tolerance, check the brushes. If the brushes appear to be good (a good brush should be at least 1/2" in length, with no sign of chips or damage and no sign of overheating), replace the motor. If the reading is within tolerance, replace the M1 harness.**

**Overheating in the brushes can be identified by discoloration of the braided copper wire.**
