Situation 8 Right Brake Fault: SIX flashes of status LED

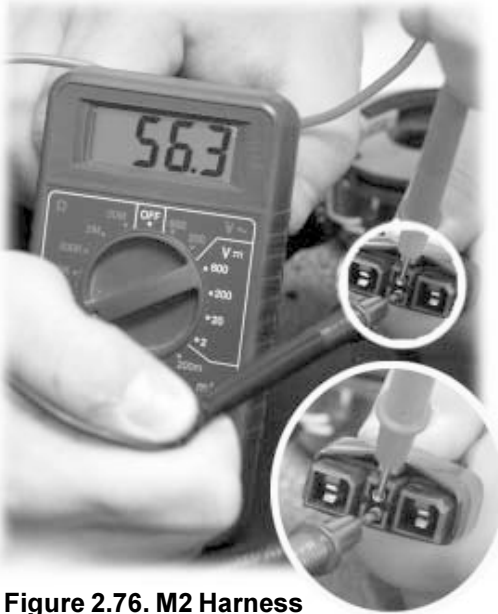
Figure 2.76. M2 Harness

Turn the meter to a resistance scale and take a reading from brake positive to brake negative (two small center pins) of the M2 harness. See figure 2.76. A reading of approximately 60 ohms should appear.

To determine if the right brake assembly is operating properly, unplug the M2 harness from the power module. See Appendix H.

If the reading appears to be within tolerance, replace the power module. If the reading is outside tolerance, move to the motor connector.

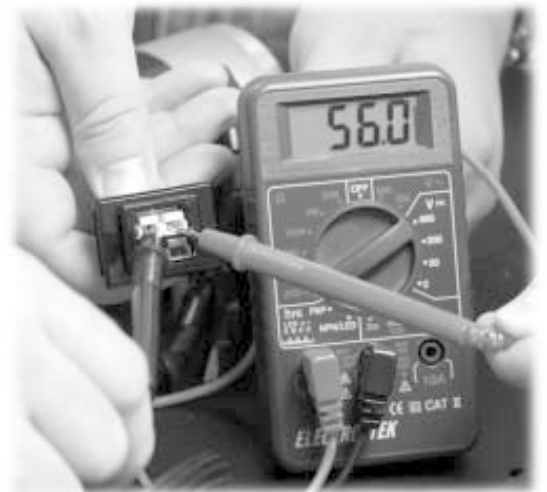
Figure 2.77. 4-pin Motor Connector

Take a reading at the 4-pin motor connector. Unplug it from the M2 harness and take a reading from the thin gauge black wires that run to the brake coil. See figure 2.77.

If the brake coils are intact, you should read approximately 60 ohms across the brake coil.

Some chairs have white connectors attached to these wires.

If the reading is outside tolerance, replace the motor brake assembly. If the reading is within tolerance, replace the M2 harness.
