Situation 4 Left Motor Disconnected

TWO flashing red LEDs

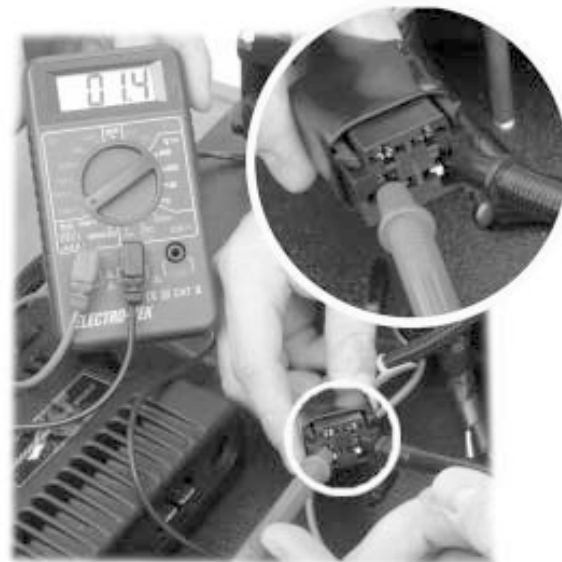
Figure 2.43. M1 Harness

The power chair interprets different faults by monitoring voltages and resistance values within the system. This error indicates that the power chair detects an “open” in the left motor or the left motor wiring. In order to determine exactly where the fault lies, you must first unplug the 4-pin harness on the top left (M1 harness) of the power module. See Appendix I. Plug the harness back in and make sure that it has a good connection. Cycle the power on and off and see if the fault is still occurring. If it is, unplug this harness one more time and turn the meter to a resistance scale. Take a reading across motor positive and motor negative on the M1 harness (two larger pins) after removing it from the power module. See figure 2.43.

If the system is working properly, you should get a reading approximately .5 to 1.5 ohms.

**If the reading is within tolerance, replace the power module. If not, check the 4-pin connector to the motor to see if there is a bad connection.**

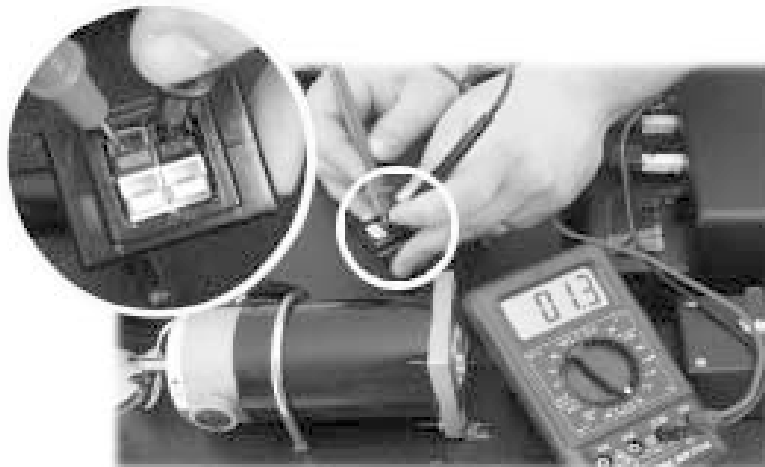
Figure 2.44. Motor Connector

Take a resistance reading from pin 1 to pin 2 of the heavy gauge red and black wires that run to the motor coil. See figure 2.44.

Some chairs have red and black connectors attached to these wires.

The reading across the motor coil should read approximately .5 to 1.5 ohms.

**If the reading appears outside tolerance, check the brushes. If the brushes appear good (a good brush should be at least 1/2" in length, with no sign of chips or damage and no sign of overheating), replace the motor. If the reading is within tolerance, replace the M1 harness.**
