Situation 6 Right Motor Disconnected

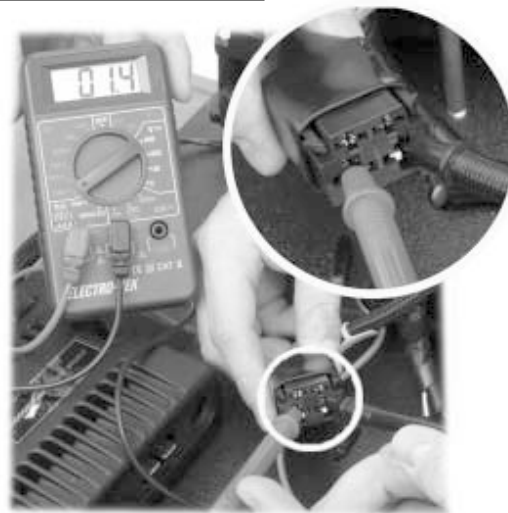
Figure 2.47. M2 Harness

Take a resistance reading across the motor positive and motor negative (two larger pins) on the M2 harness. See figure 2.47. If the unit is operating properly, you should read approximately .5 to 1.5 ohms.

If the reading is within tolerance, replace the power module. If not, proceed to the 4-pin motor connector.

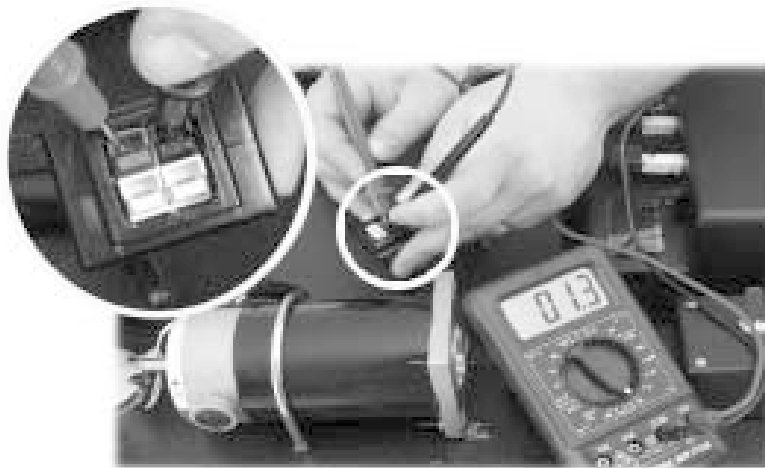
Figure 2.48. Motor Connector

Take a resistance reading from the heavy gauge red and black wires that run to the motor coil. See figure 2.48.

Some chairs have red and black connectors attached to these wires.

The reading should read approximately .5 to 1.5 ohms.

If the reading appears outside tolerance, check the brushes. If the brushes appear good (a good brush should be at least 1/2" in length, with no sign of chips or damage and no sign of overheating), replace the motor. If the reading is within tolerance, replace the M1 harness.
