Situation 3 Dx Module Fault

Situation 4 Dx Accessory Fault

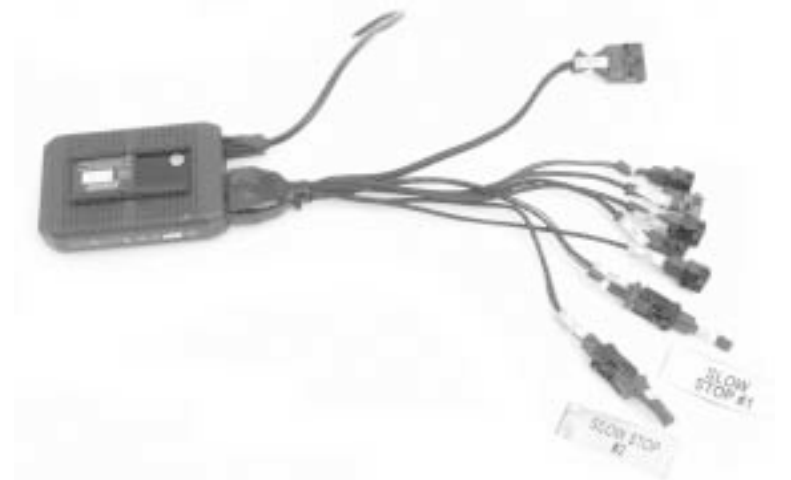
Check the slow / stop inputs on the Combined Light and Actuator Module (CLAM) harness. See figure 2.69. On this harness there are two run plugs which need to be attached in order for the system to work when using this module. These plugs should be located on the slow stop #1 and slow stop #2 of this harness, if they are not present it will cause this fault to occur.

Figure 2.69. CLAM Module and Harness

Check the status indicator LED on accessory modules. If accessory module(s) indicates a fault, replace the module. If the status LED remains solid, move to the Clam harness.
