## Situation 6 Right Motor Fault: FOUR flashes of status LED

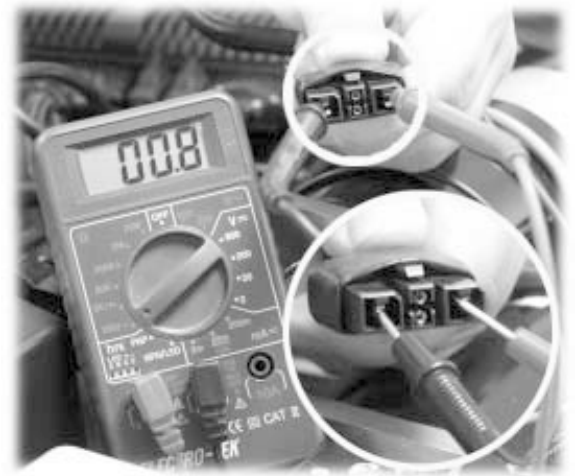
Figure 2.72. M2 Harness

Take a resistance reading across the motor positive and motor negative (two larger pins) on the M2 harness. See figure 2.72. If the unit is operating properly, you should read approximately .5 to 1.5 ohms.

This fault indicates that there is a bad connection in the right motor. Make sure that the M2 harness connection to the power module is good. See Appendix H. Unplug this harness and then plug it back in and see if a fault is still occurring. If it is, unplug this harness and turn the meter to a resistance scale.

**If the reading appears within tolerance, replace the power module. If not, move to the 4-pin harness that connects to the right motor.**

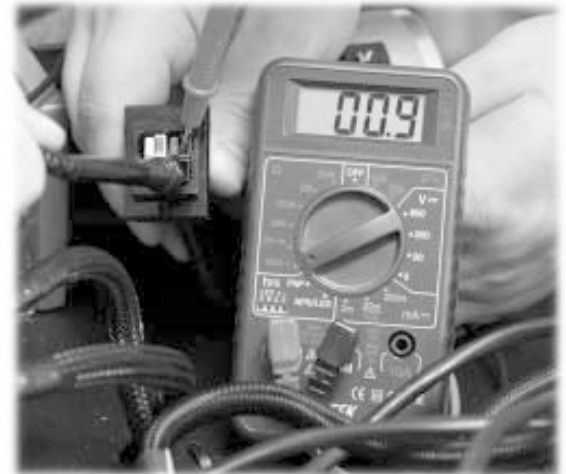
Figure 2.73. Motor Connector

Take a resistance reading from the heavy gauge red and black wires that run to the motor coil. See figure 2.73.

The reading across the motor coil should read approximately .5 to 1.5 ohms.

**Some chairs have red and black connectors attached to these wires.**

**If the reading appears outside tolerance, check the brushes. If the brushes appear to be good (a good brush should be at least 1/2" in length, with no sign of chips or damage and no sign of overheating), replace the motor. If the reading is within tolerance, replace the M1 harness.**

**Overheating in the brushes can be identified by discoloration of the braided copper wire.**
